Chignik Lake School Sewer and Generator Building Expansion Projects

Cultural Heritage Studies
Environment and Natural Resources Institute
University of Alaska Anchorage
June, 2003

The Project

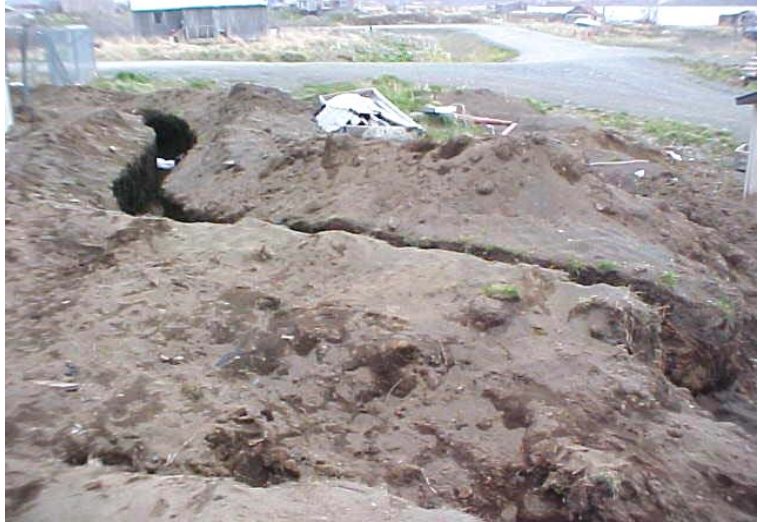
Figure 4. View of southeast portion of the sewer line trench, view northwest.

The sewer line trench was excavated prior to the survey to a depth of ~1 meter below ground surface. The trench begins north of the new housing duplex, and curves around the existing teacher's housing for approximately 50 feet, before turning to the west where it connects to the existing line 80 feet away (Figures 4 & 5). The proposed generator building expansion will extend the northwest side of the existing building approximately 5 meters to the northwest. This construction consists of adding fill from the local gravel pit to the existing surface as padding prior to extending the building. No subsurface disturbance will occur as a result of this construction, and all new utilities lines will be positioned above ground.

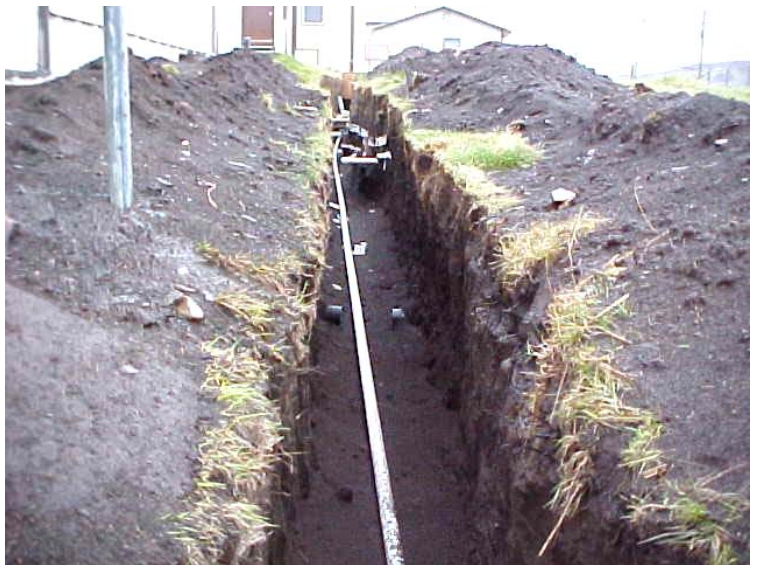
Figure 5. View of northwest portion of trench facing southwest. Note disturbance from an existing leach field.

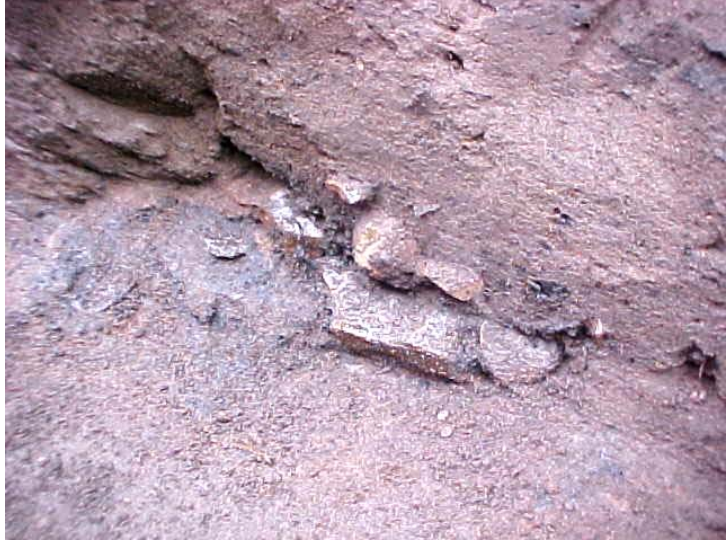
The lower feature consisted of an inclusion of black (7.5YR 2.5/1) silt and charcoal within which was located several large fragments of sandstone and a spherical object of tephra with a crusted outer surface (Figure 3, Location No 2; Figure 6). A radiocarbon sample was acquired from beneath the tephra sphere, ~101 cm below ground surface, however, the sample has not been assayed. No artifacts were recovered in direct association with this sandstone, although a net sinker and grinding stone were collected from the trench floor in front of the profile.

Figure 6. Close-up of feature in trench segment 2. Arrow denotes location of tephra ball.

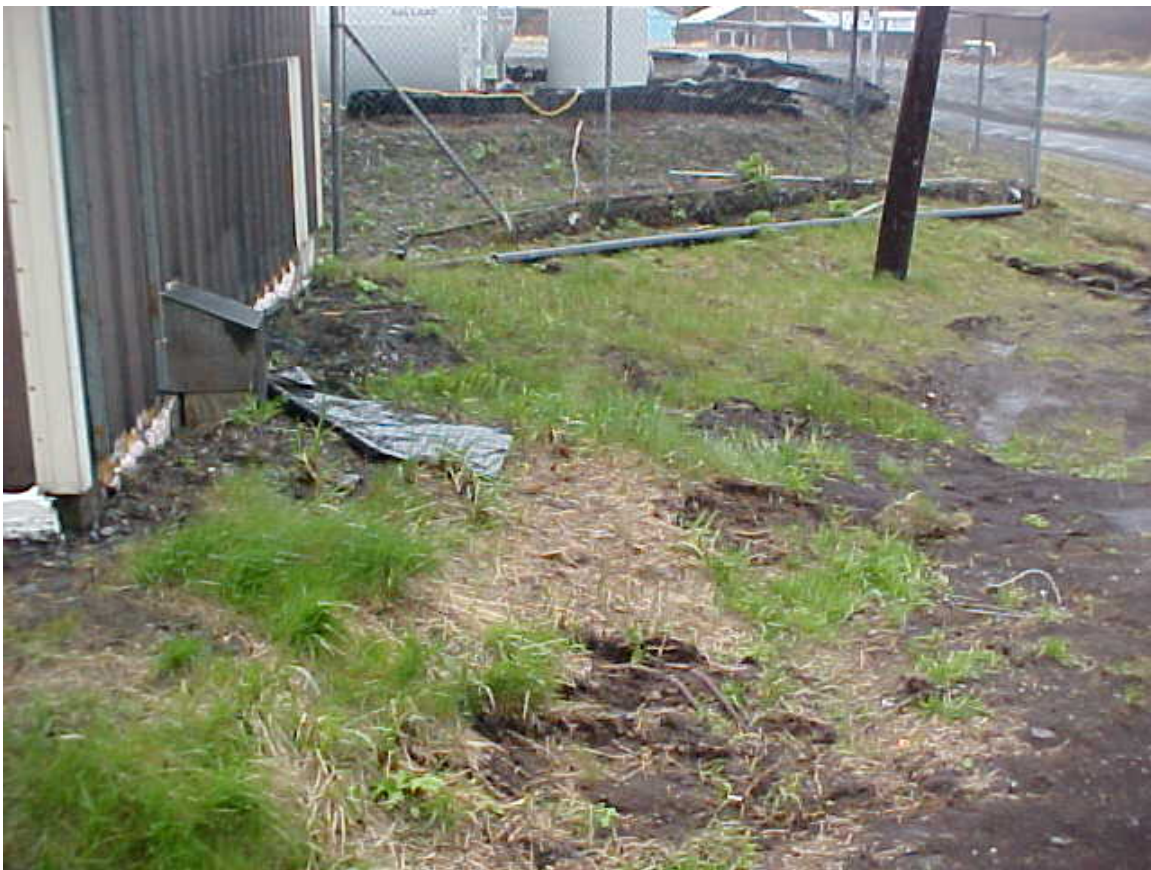
One shovel test was excavated in the location of the proposed building pad to a depth of ~65 cm below ground surface (Figure 12). Three strata were observed in the test: a very dark gray (10YR 3/1) silty sand mixed with a brownish yellow (10YR 6/6) coarse sand to ~24 cm, followed by a brown (10YR 4/3) silty sand to ~40 cm below ground surface, and a very dark grayish brown (10YR 3/2) coarse sand to the base of the excavation.

Figure 12. Location of generator building extension. Building will be extended to location of existing utility pole.

The shovel test excavated in the generator building project area revealed no intact cultural deposits, but a single flake was found. Additional surface collections of the surrounding area resulted in the recovery of no additional materials. Subsurface excavation will not occur with the proposed project, and the fill for the project will be obtained from the local gravel pit. Based on these factors, no adverse effect is expected with this construction, however, if construction plans should change, this decision should be re-evaluated.
